# Erosion of Concrete in Hydraulic Structures

## Reported by ACI Committee 210

*This report outlines the causes, control, maintenance, and repair of erosion in hydraulic structures. Such erosion occurs from three major causes: cavitation, abrasion, and chemical attack. Design parameters, materials selection and quality, environmental factors, and other issues affecting the performance of concrete are discussed.*

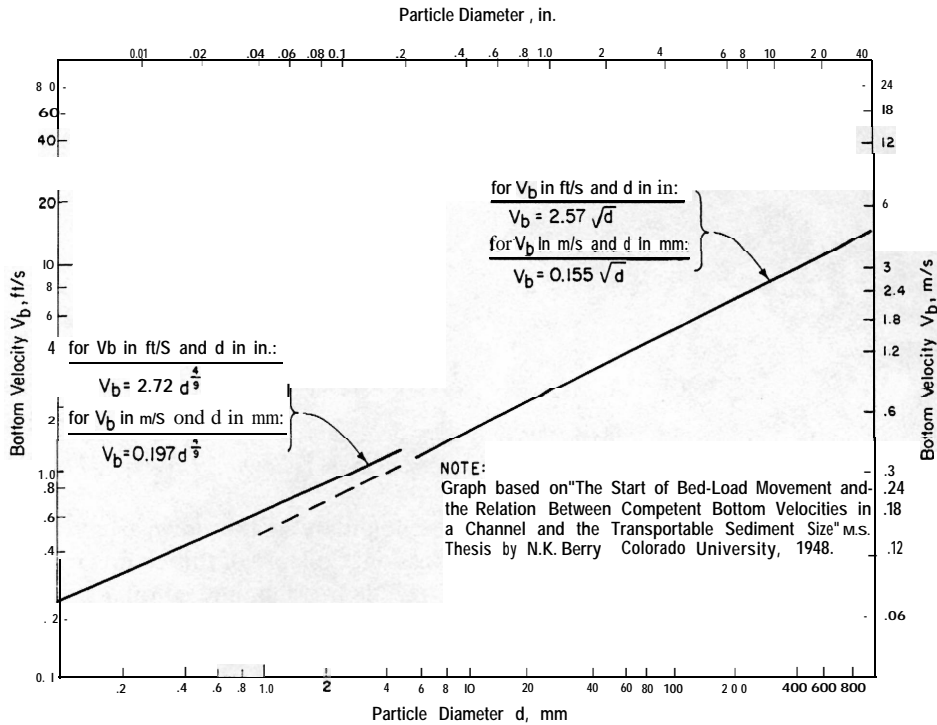
Fig. 3.2-Bottom velocity versus transported sediment size

The rate of erosion is dependent on a number of factors including the size, shape, quantity, and hardness of particles being transported, the velocity of the water, and the quality of the concrete. While high-quality concrete is capable of resisting high water velocities for many years with little or no damage, the concrete cannot withstand the abrasive action of debris grinding or repeatedly impacting on its surface. In such cases, abrasion erosion ranging in depth from a few inches (few centimeters) to several feet (a meter or more) can result depending on the flow conditions. Fig. 3.2 shows the relationship between fluid-bottom velocity and the size of particles which that velocity can transport.

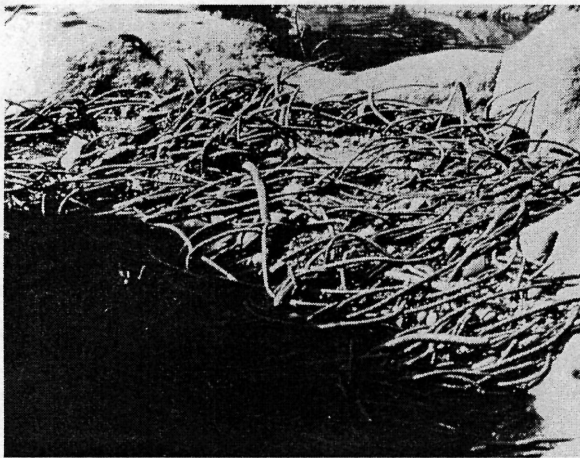
Fig. 3.3-Typical debris resulting from abrasion erosion of concrete

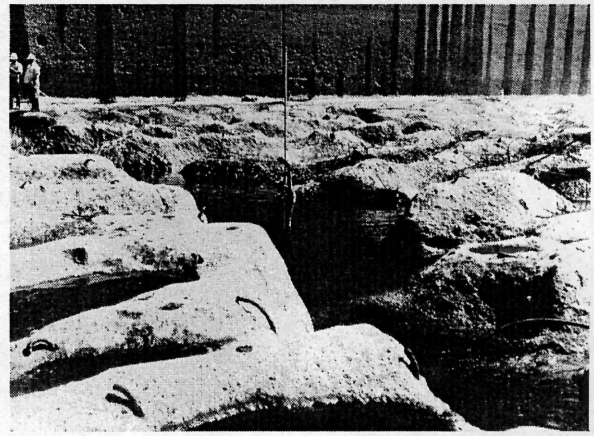
Fig. 3.4-Erosion of stilling basin floor slab, Dworshak Dam

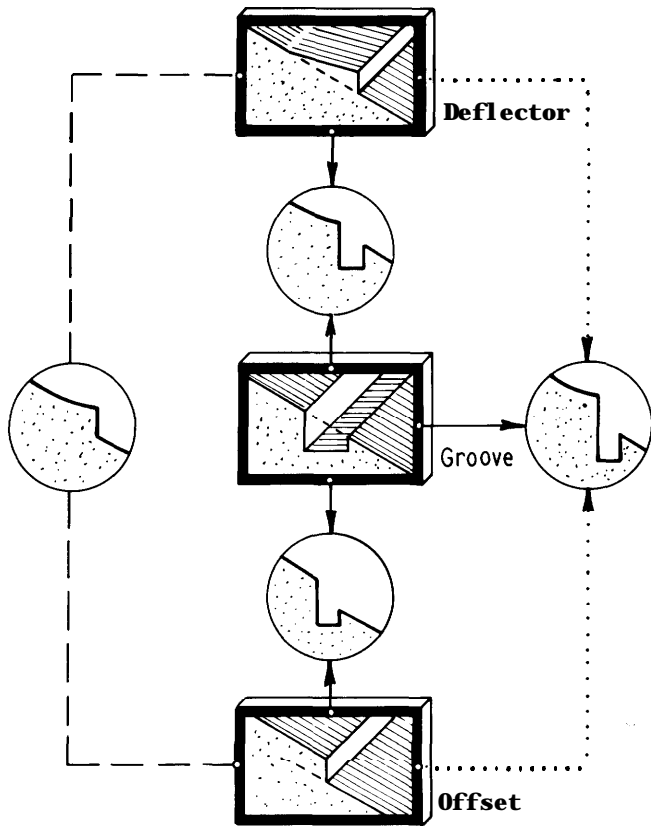
Fig. 5.4-Types of aerators (from Vischer, Volkart, and Siegenthaler, 1982)

As indicated above, ramps and down-steps are used to induce the flow in a spillway or tunnel to spring free from the floor. A ramp is a wedge anchored to or integral with the floor and usually spans the tunnel or spillway bay. Ramps vary in length from 3 to 9 ft (1 to 3 m). Wall and corner wedges and wall offsets away from the flow also are used to cause the water to leave the sides of a conduit. The objective is to provide a sudden expansion of the solid boundaries. Such devices, often referred to as aerators, are visually depicted in Fig. 5.4 and 5.5. (See also Ball 1959, DeFazio and Wei 1983, and Russell and Ball 1967.)

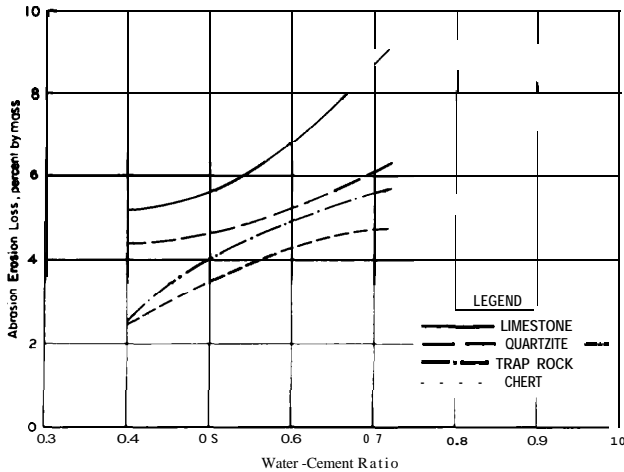
Fig. 6.1-Relationships between water-cement ratio and abrasion-erosion loss
